Navajo Abandoned Uranium Mine

Site Screen Report

Boyd Tisi No. 2 AUM Site

Navajo AUM Western Region

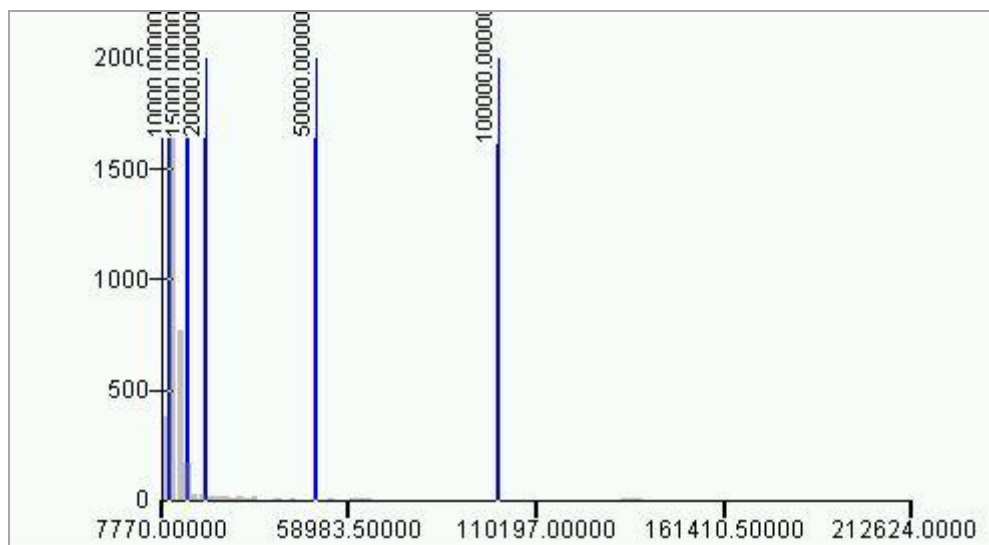
The following chart and statistics were generated by ESRI ArcGIS 9.3.1, and show the general distribution of the site gamma radiation measurements. The horizontal X axis represents the gamma radiation reading levels in cpm (lowest levels to the left). The vertical Y axis represents the frequency of each gamma radiation level.

Count:	3359
Minimum:	7770.00000
Maximum:	212624.00000
Sum:	52590614.00000
Mean:	15656.62816
Median:	11275.00000
Standard Deviation:	19871.92767

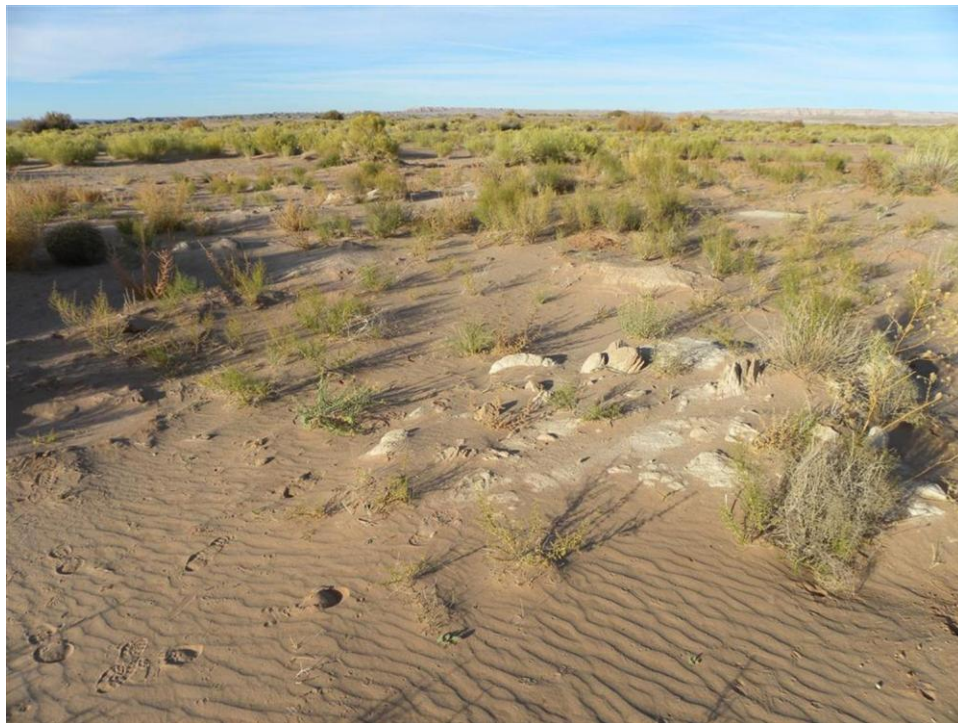
Photo 3. Boyd Tisi No. 2 mine site, waste pile area

A total of 3,359 gamma radiation measurements were collected from the mine site, ranging from 7,770 cpm to 212,624 cpm. The measurements collected at the waste pile were found at a maximum level of approximately 130,000 cpm, and a petrified log near the structures 0.15 mi west of the site was found at over 200,000 cpm. The measurements are represented in Figures 1 and 2.

1 round waste pile, 25' diameter x 1' h

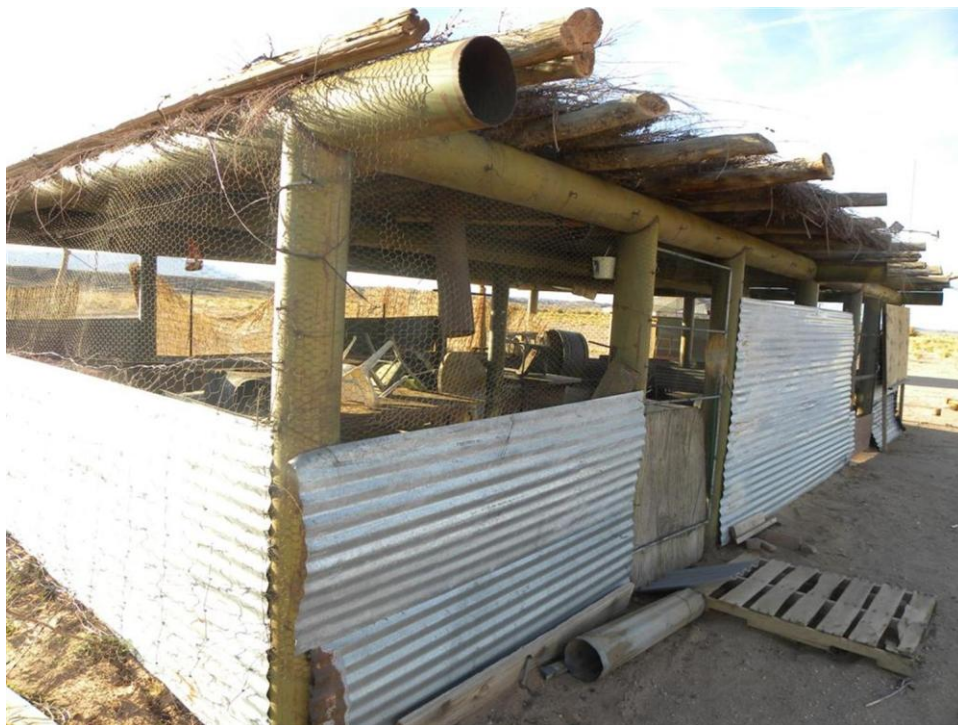
Photo 4. Boyd Tisi No. 2 mine site, nearby structures

200 feet to 0.25 mile: 5 structures approximately 0.15 mi W of site (1 hogan, 1 small mud structure, 1 garage cover, 1 cooking area, 1 outhouse)

Background levels around structures, with exception of petrified log at 200,000 cpm

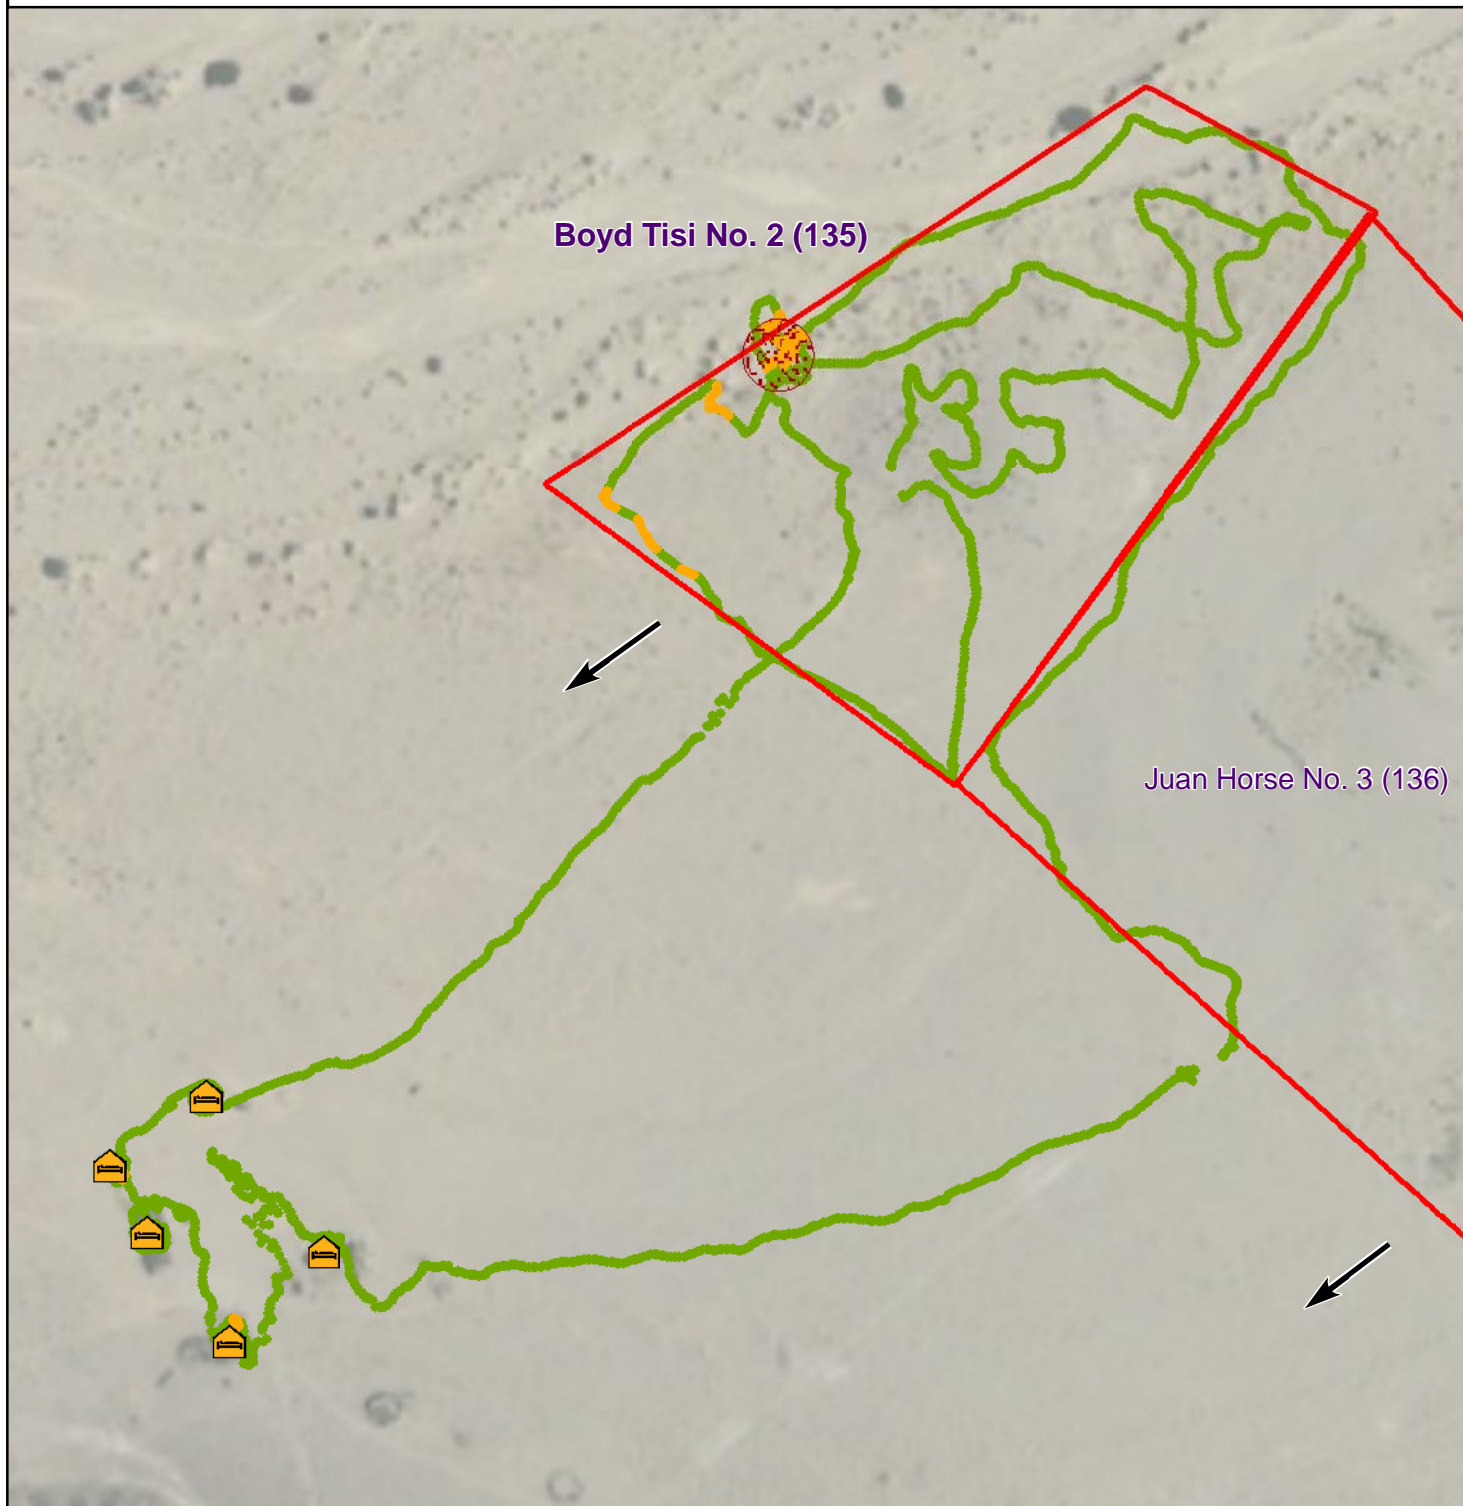
**Figure 2 - Gamma Radiation Measurements, Above Two Times Background
Boyd Tisi No. 2 (135)
Coalmine Mesa Chapter, Navajo Nation**

Gamma survey conducted 11/2010
Measured as counts per minute (cpm)

Average background 11,523 cpm

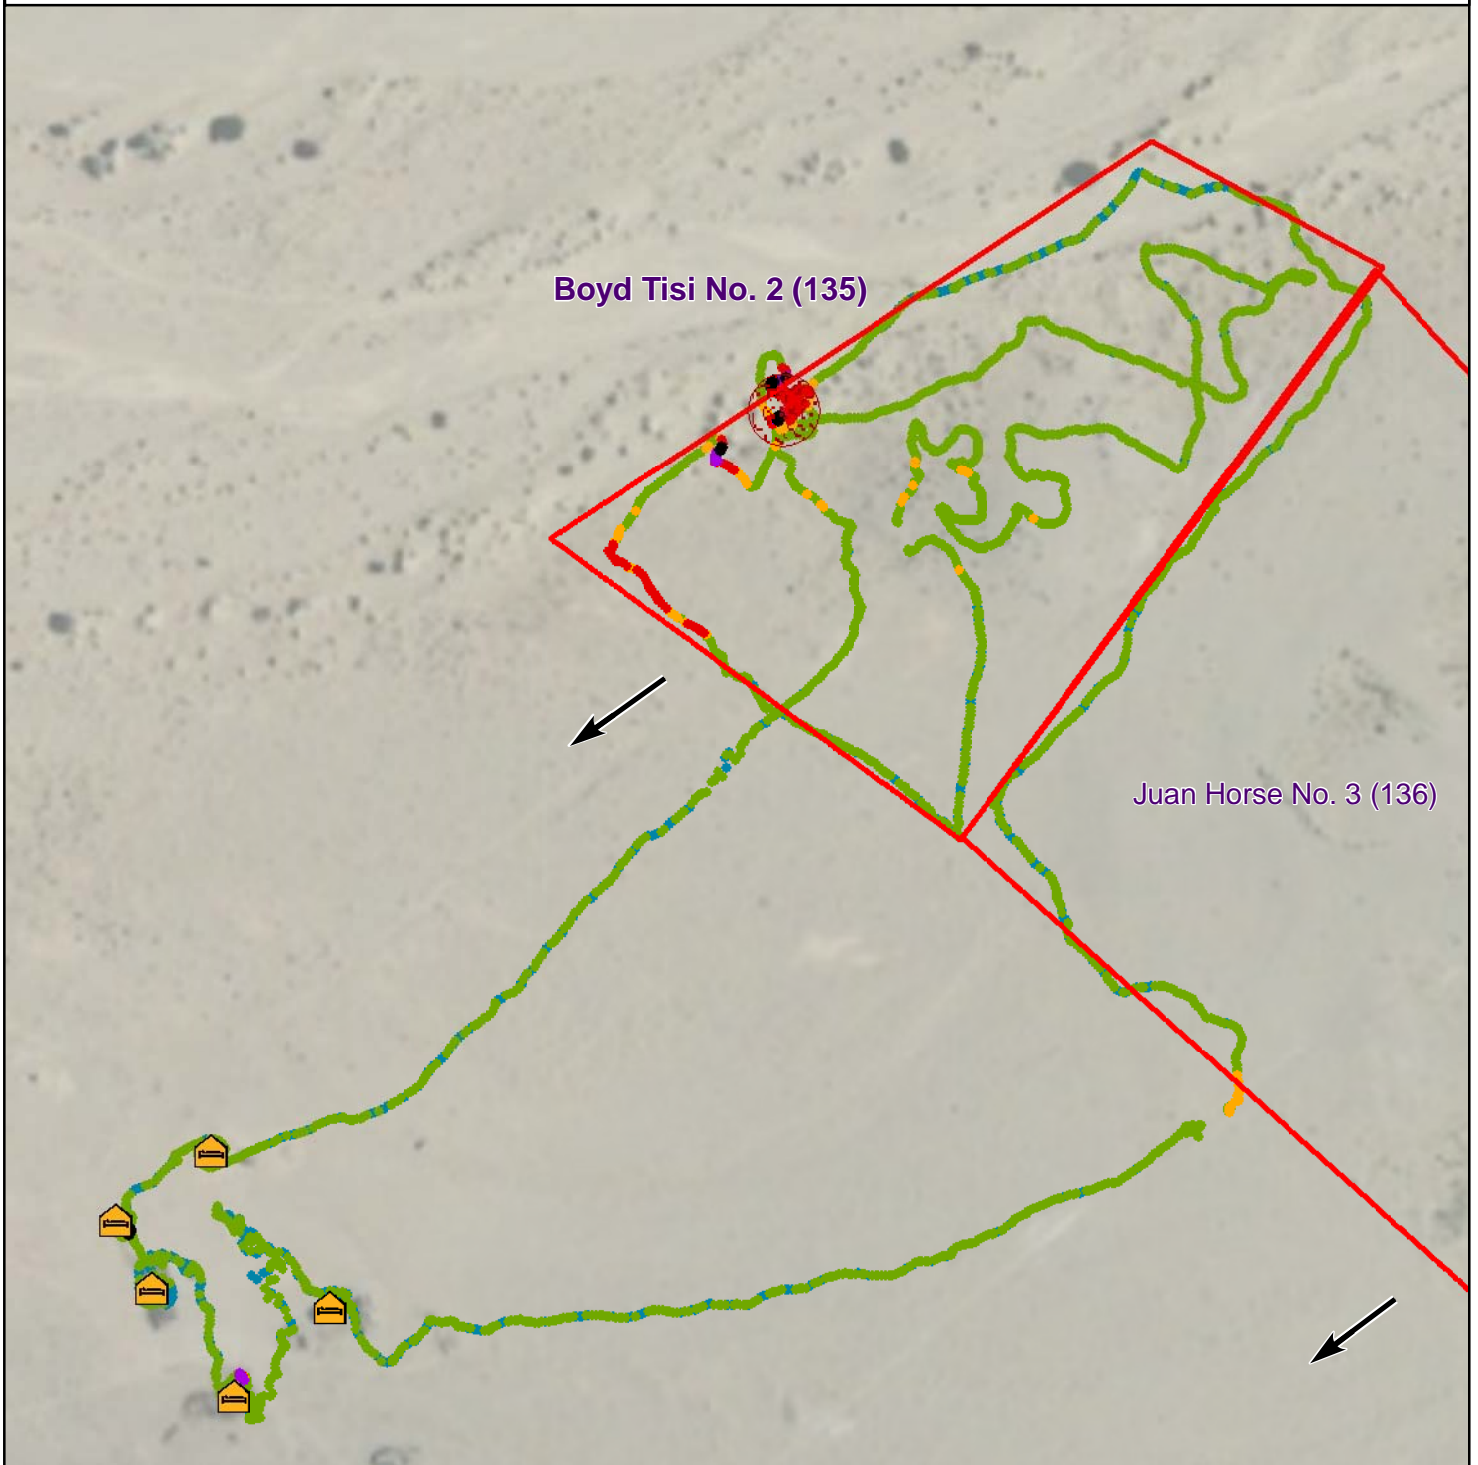
**Figure 2 - Gamma Radiation Measurements
Boyd Tisi No. 2 (135)
Coalmine Mesa Chapter, Navajo Nation**

**Gamma survey conducted 11/2010
Measured as counts per minute (cpm)**

Average background 11,523 cpm
